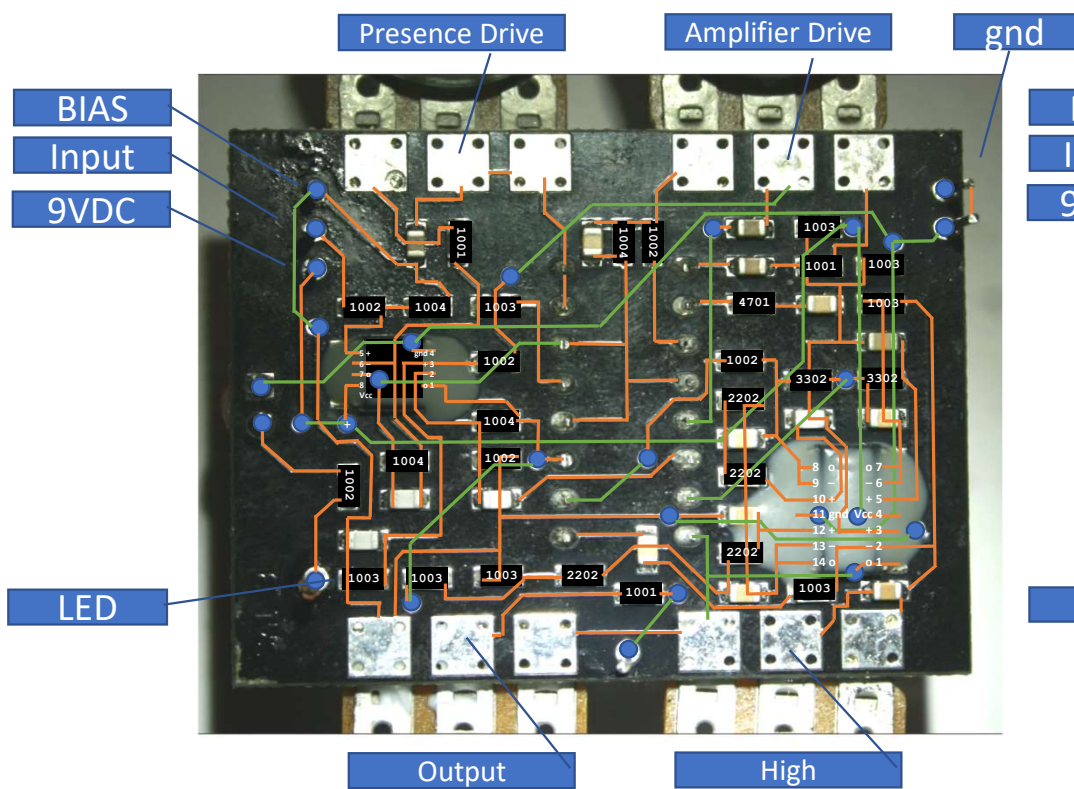
Photo of deconstructed replacement board. Attempted mirror image of reverse (top) side for traces and mapping vias.

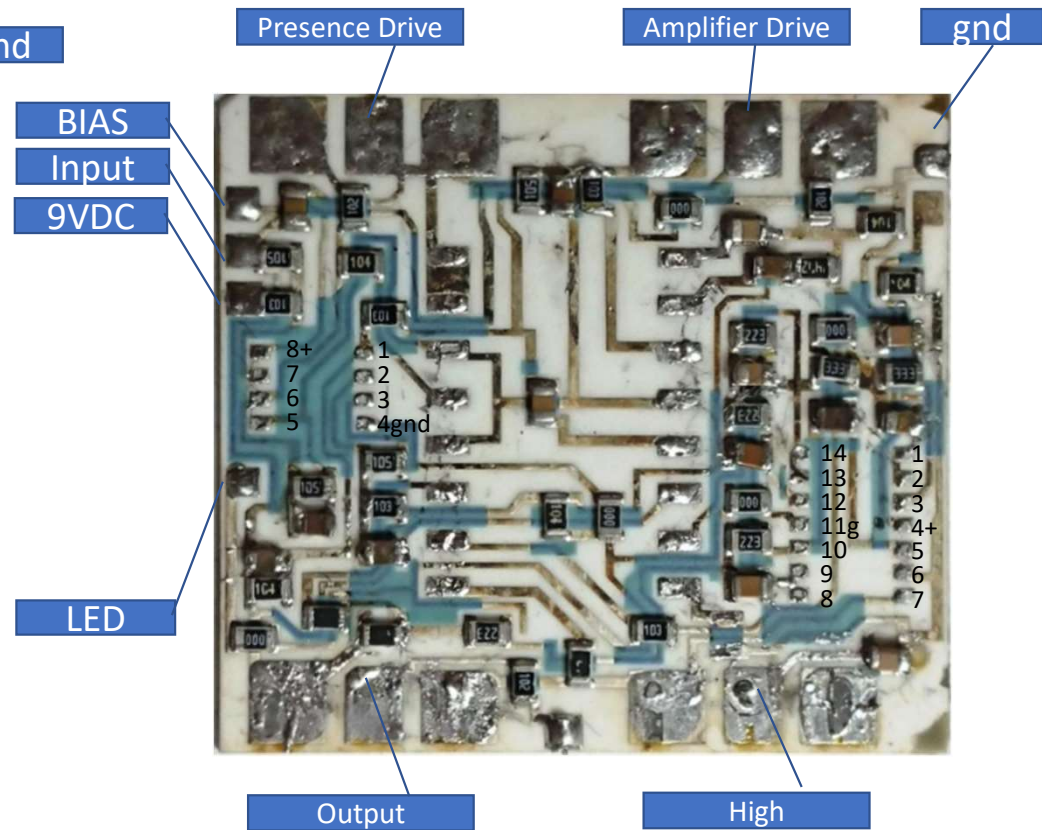
Comparison of replacement board to original (from original Japanese board?)

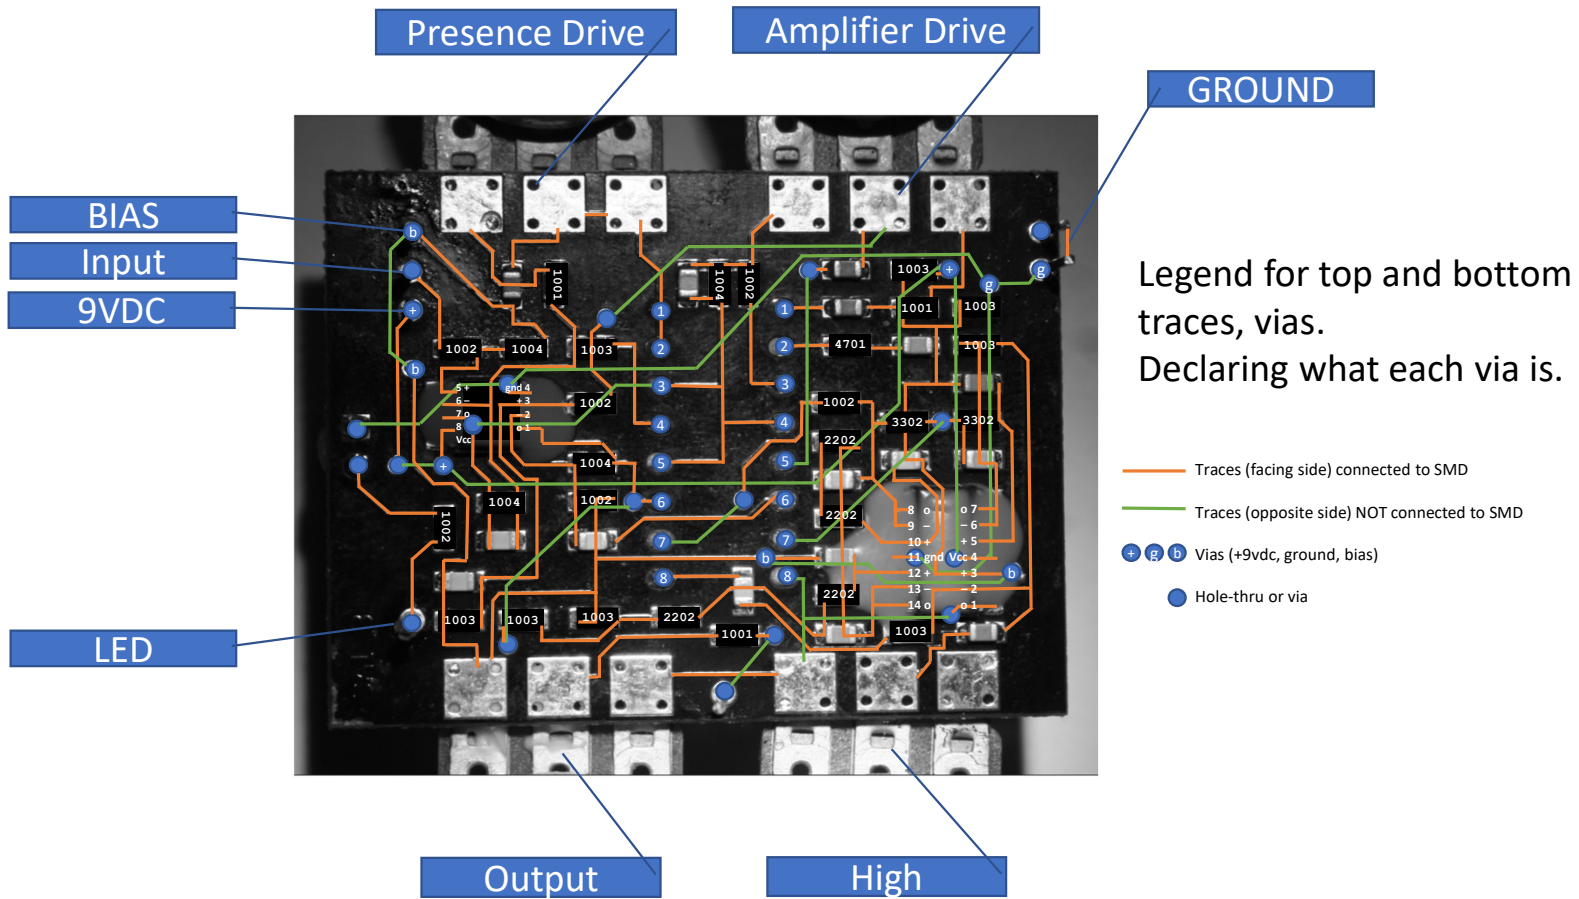
Mirror copy of original board to match new one  
Resistor values mirrored back for readability  
Opamps are now backwards (sorry)
